Manhole Inspection Summary

Manhole # S4300_028MH

Insp Date: **12/12/07 9:51 AM**

Location Address: **Darley**

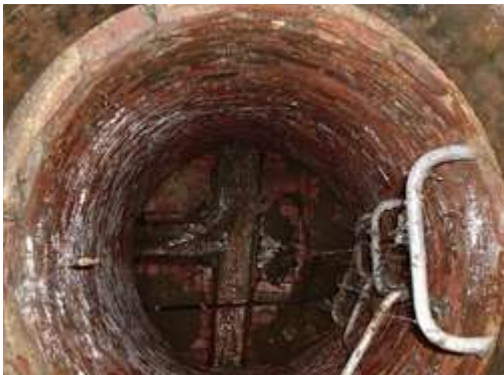
Defect 1

Infiltration: ☐ None ☐ Joint ☐ Cracks ☐ Mortar ☐ Roots ☒ **Wall**

INFILTRATION

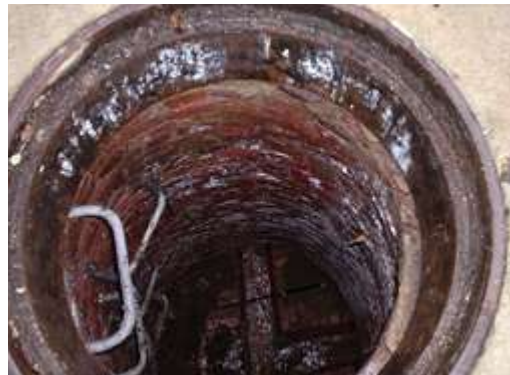
Defect 2

Offset: **0.5** (in.)

☒ **Leaks**

FRAME LEAKS

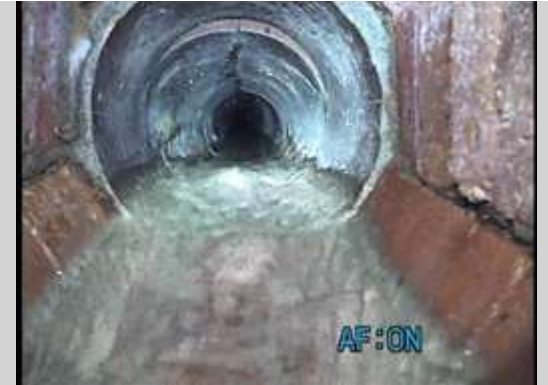
12 O'Clock Outflow

8 in. Circular Gravity Sewer
Pipe Out @ 12 O'Clock

Pipe Height: **8.4** (in.) Rod and Bar (Angled)
Pipe Material: **Clay** ☐ Pipe Lined
Invert Depth: **10.50** (ft.) Flow Characteristics: **Fast**
Deposits: ☒ None ☐ Mud ☐ Sludge ☐ Debris ☐ Grease
Silt Depth: (in.) Deposits Extent:
Infiltration: **None** Pipe Seal Cond: **Sound**

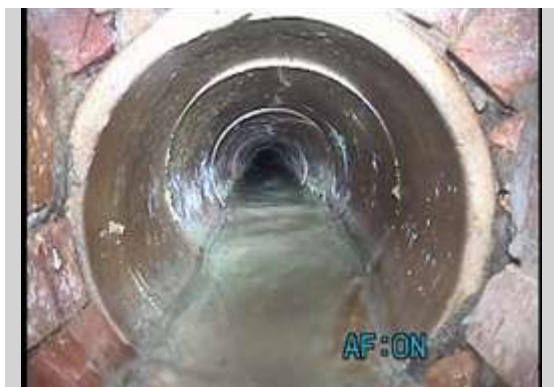
9 O'Clock Inflow

Pipe In @ 9 O'Clock

Infiltration: **None** Pipe Seal Cond: **Sound**
